BLM-Alaska Open File Report 64  
BLM/AK/ST-97/022+8111+040  
April 1997

# HISTORIC BUILDING SURVEY REPORT FLAT, ALASKA

by Rolfe G. Buzzell and Darrel L. Lewis

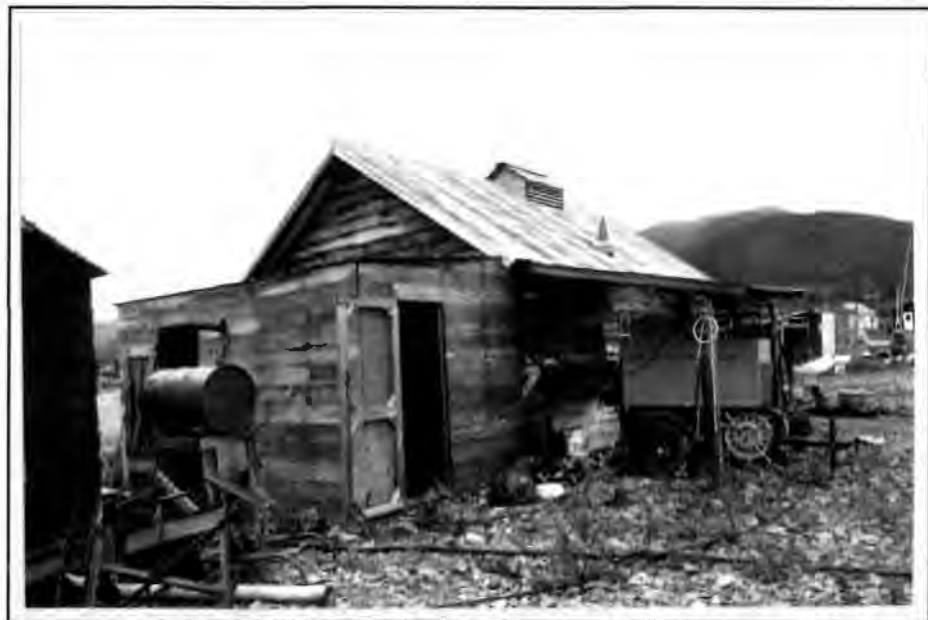
Figure 148. The Golden Horn Powerhouse,  
1993. The view is looking northwest.

The Golden Horn Powerhouse (IDT-217) is a rectangular, one-story, wood frame building (Figure 148). The foundation consists of

wood blocks. The gable roof is made of corrugated metal and has a small cupola. The building measures 16'2"x22'2". Shiplap siding covers the exterior walls. The main entry is on the west elevation, which contains a pair of plywood doors and a plank door. The east elevation has a six-light, fixed sash window and a 7'x7'9" addition. The addition, which shelters a generator, has a shed roof covered with roofing felt. The south elevation of the Powerhouse has a plank door and a six-light, fixed sash window. The window is covered by an 8'4"x13'7" addition. The addition has a shed roof covered with corrugated metal. There is a plank door on the south and west sides of the addition and a screen door on the east side. The north elevation has a plank door and a six-light, fixed sash window.

A lean-to on the north elevation has a shed roof covered with corrugated metal. The lean-to measures 12'4"x19'8", has no walls, and shelters a Wilfley table. A welding shed measuring 6'2"x15'5" (Feature X, Figure 133) is located 7'9" east of the Powerhouse. The shed has a metal pole frame and no walls. The shed roof is covered with corrugated metal.

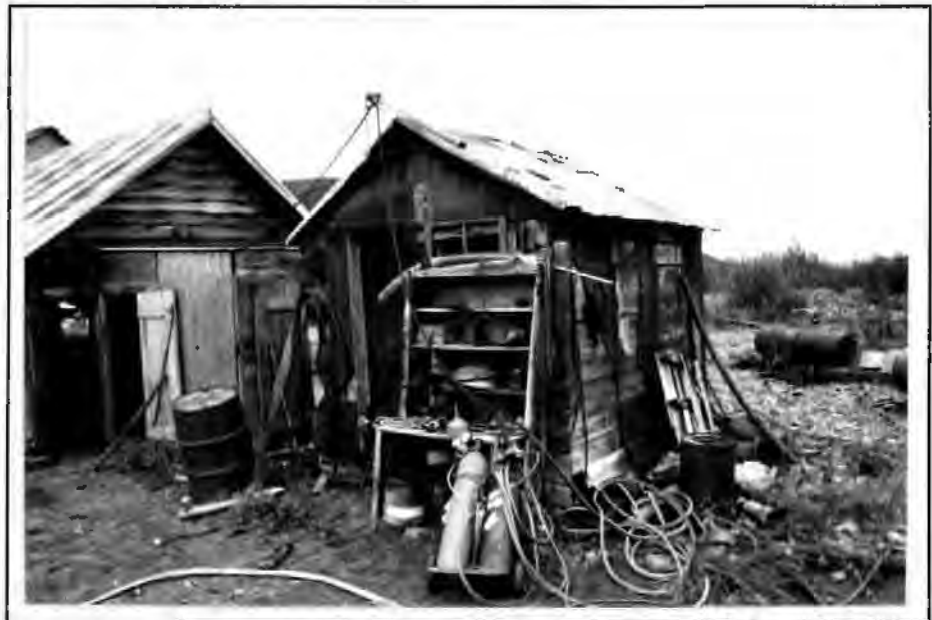
**Figure 149. The Drill Shack on Skids, 1993. The view is looking northeast.**

The **Drilling Shack on Skids (IDT-218)** is a rectangular, one-story, wood frame building (Figure 149) located about 8' south of the Golden Horn Powerhouse. The foundation is timber skids. The gable roof is covered with corrugated metal. The shack measures 8'2"x10'2". The exterior is covered with roofing felt over wood siding. The main entry is on the west elevation, which has a plank door and a single-light, fixed sash window.

When and where this shack was built are unknown. It was used as a drilling shack at the Discovery/Peter Miscovich Camp in the 1940s and 1950s before John Miscovich moved the building to the Riley/Otter Creek Camp in the 1960s (Miscovich 1995:VI-106).

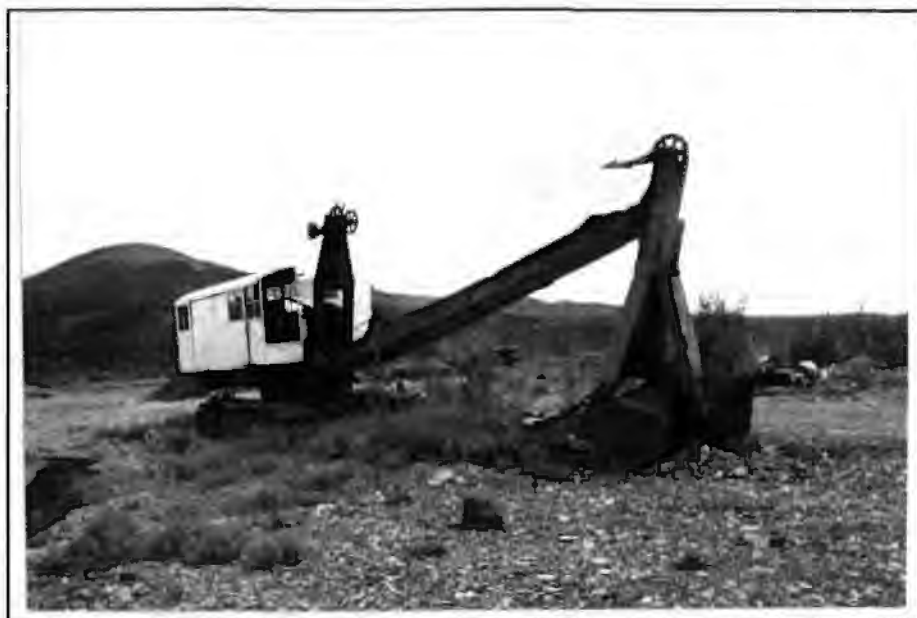
**Figure 150. The Miscovich Shovel, 1993.**  
The view is looking southwest.

The **Miscovich Shovel (IDT-219)** is a 2.5 yard capacity shovel manufactured by the Pauling and Harnish Figure Corporation, of Milwaukee, Wisconsin. The shovel (Figure 150) is a diesel powered, track vehicle with an enclosed cab. It is mechanically operated and has no hydraulically operated controls. It weights about 65 tons. All of the mechanisms are in good working condition. The shovel originally had a 1.5 yard capacity bucket. John Miscovich enlarged the capacity by extending the sides of the bucket and putting larger shanks on the lip of the bucket.

Peter Miscovich bought the shovel in 1935 and brought it up the Iditarod River by boat. John Miscovich assembled it and "walked" it overland to Flat. The Miscovich family used it for placer mining until World War II. After the war, they resumed using it on their Otter Creek claims. John Miscovich also used it in the early 1970s while mining on Flat Creek. He stopped using the shovel about 1974 or 1975 (Miscovich 1995:VI-106-107).

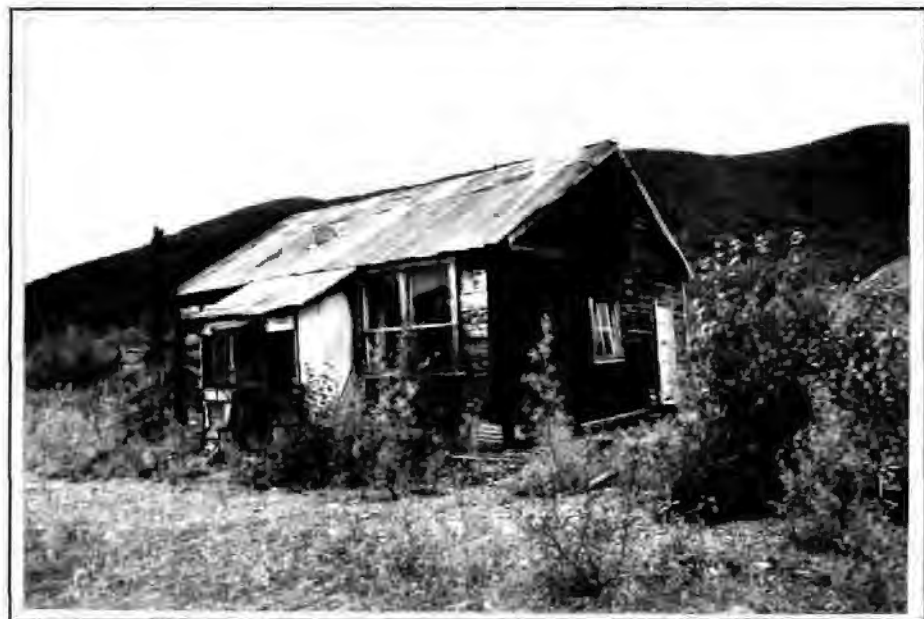
**Figure 153.** The Bunkhouse at the Discovery/Peter Miscovich Camp, 1993. The view is looking northwest.

**The Bunkhouse (IDT-222)** is a rectangular, one-story wood frame building (Figure 153). The foundation consists of steel drums. The gable roof is covered with corrugated metal and the exterior is covered with roofing felt over horizontal rough cut siding. The main entry is on the south elevation, which has a pair of 2/2 single-hung windows and a four-light fixed sash window. An arctic entry with a shed roof is centered on this elevation. Corrugated metal covers the roof and the sides are covered with celotex. A screen door faces south. The east elevation has a six-light, fixed sash window and a five-panel door. The north elevation has a window covered with corrugated metal. The west elevation has a 1/1 single-hung window and a one-light, fixed sash window.

Peter Miscovich built the bunkhouse in 1928 after the original log bunkhouse burned down. He used local rough cut lumber for the siding. The building was the mess hall and cook's quarters (Miscovich 1995:VI-99-100).

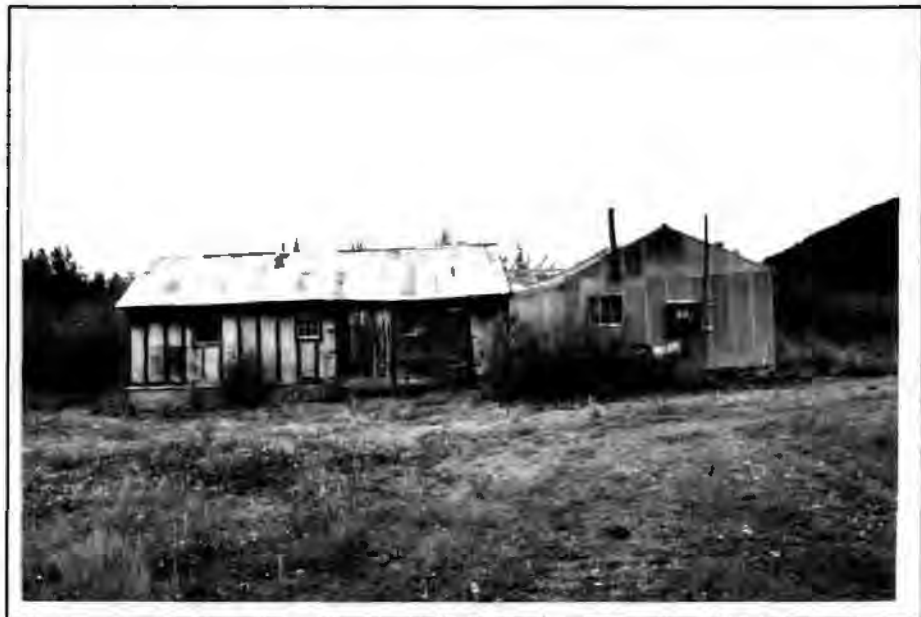
Figure 154. The Workshop and Garage, 1993.  
The view is looking west.

The **Workshop and Garage (IDT-223)** is an "L" shaped, one-story, wood frame building (Figure 154). The northern part of the building is rectangular in shape and has a gable roof oriented east-west. The roof and exterior walls are covered with corrugated metal. The east elevation has a six-light, fixed sash window. The north elevation has a six-light, fixed sash window and a large utility door with a six-light, fixed sash window. A short, gable roof addition connects the workshop and garage with a smaller addition on the south. This addition is rectangular with a gable roof oriented north-south. The roof is covered with corrugated metal and the exterior is covered with celotex and batten boards. The east elevation has a pair of large side opening doors and two six-light, fixed sash windows. The west elevation has a six-light, fixed sash window.

Peter Miscovich built the northern portion of the workshop and garage building in 1935. He used the building to store and maintain tractors. The southern portion of the building was the powerhouse at the Wireless Station in Flat (IDT-130). John Miscovich moved the powerhouse to the Discovery/Peter Miscovich Camp and attached it the garage (Miscovich 1995:IV-50; VI-100).

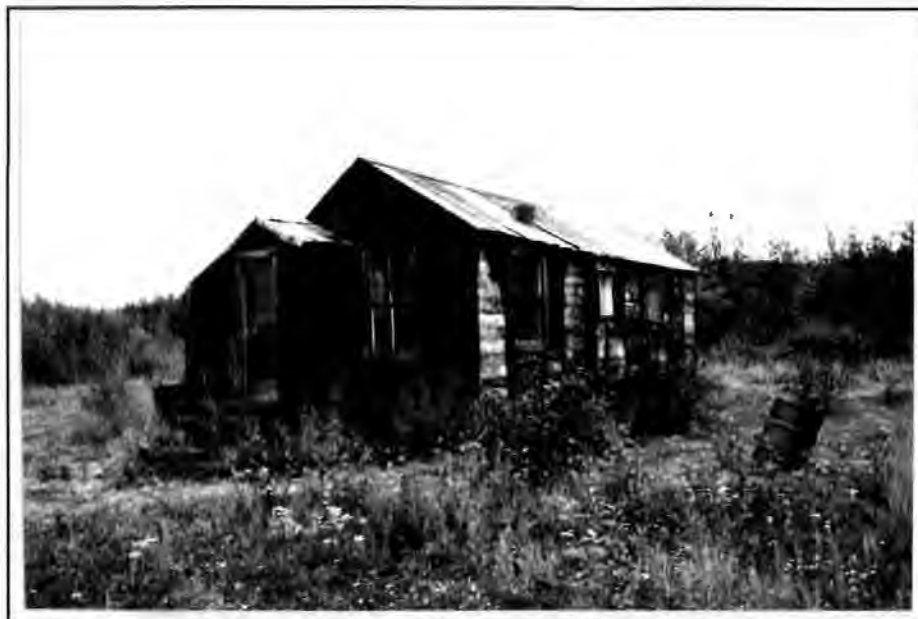
**Figure 155. The Peter Miscovich Office/Residence, 1993. The view is looking southeast.**

The **Peter Miscovich Office/Residence (IDT-224)** is a rectangular, one-story, wood frame building (Figure 155). The foundation is log piers. The gable roof is covered with corrugated metal. The exterior is covered with roofing felt over shiplap and wood siding. The main entry is on the north elevation, which contains a 2/2 single-hung window. An arctic entry with a gable roof covered with corrugated metal is located on the east side of the north elevation. The exterior of the arctic entry is covered with roofing felt over shiplap. A one-panel door with one light faces north. The east elevation of the Office/Residence has a two-light, fixed sash window. The west elevation has a 1/1 single-hung window, a two-light, fixed sash window, and a window opening with no glass. The south elevation has a one-panel door with one light.

This building was constructed in the 1920s about 300 yards from its present location. Peter Miscovich bought this building in 1948 from Martin Roslin and moved it to the Discovery/Peter Miscovich Camp after his original office/residence building was destroyed by a fire in 1947. Miscovich added the arctic entry on the north side after the building was moved (Miscovich 1995:VI-100).

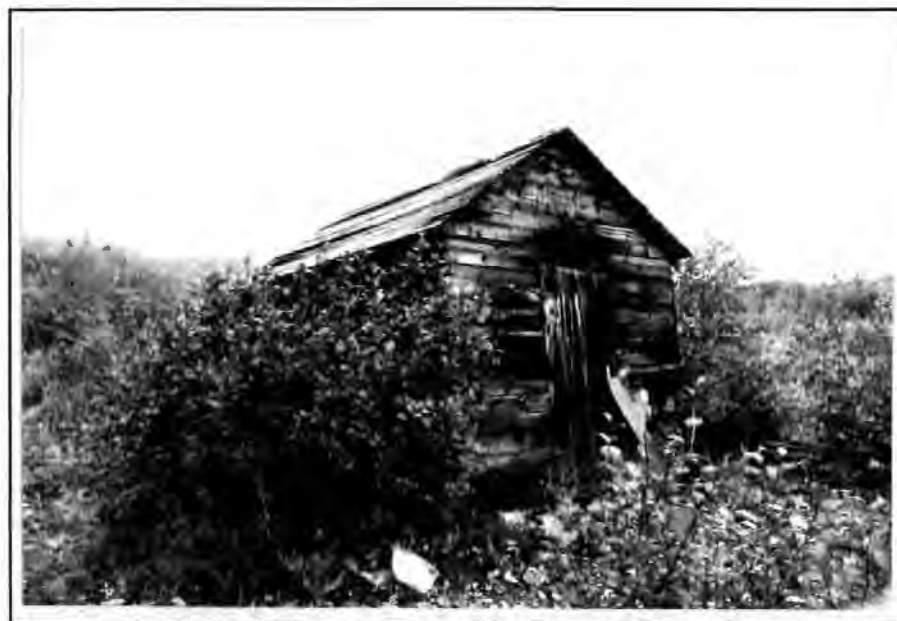
**Figure 156. The Parts Shed, 1993. The view is looking northeast.**

The **Parts Shed (IDT-226)** is a rectangular, one-story, wood frame building (Figure 156). The foundation is horizontal timbers on grade. The gable roof and exterior walls are covered with wood decking. The main entry is on the south elevation, which contains a plank door. The building has no other doors or windows.

The date the Parts Shed was built and whether it has been moved are unknown. Peter Miscovich used the building to store equipment parts (Miscovich 1995:VI-100).

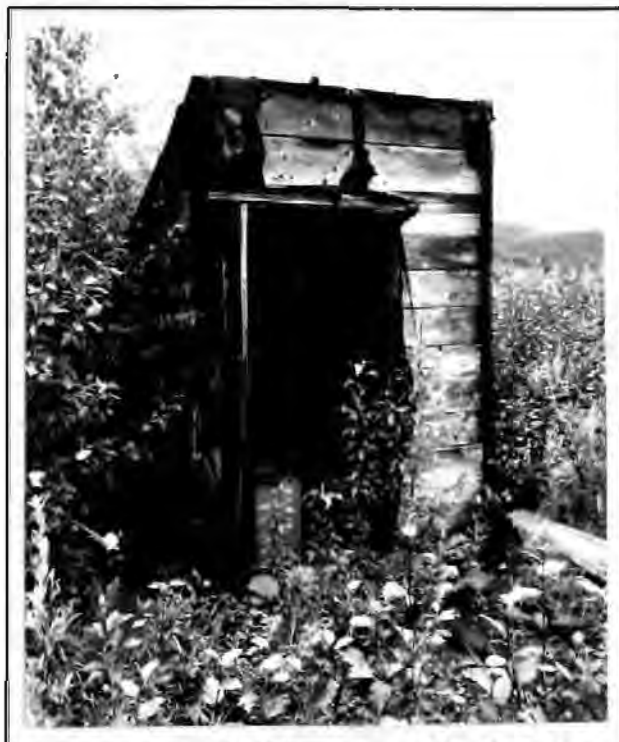
Figure 157. The Generator Shed, 1993.  
The view is looking north.

The Generator Shed (IDT-225) is a rectangular, one-story, wood frame building (Figure 157). The foundation is on grade. The shed roof and exterior walls are covered with roofing felt over wood decking. The main entry is on the south elevation, which contains a door opening but no door. The building sheltered a generator.

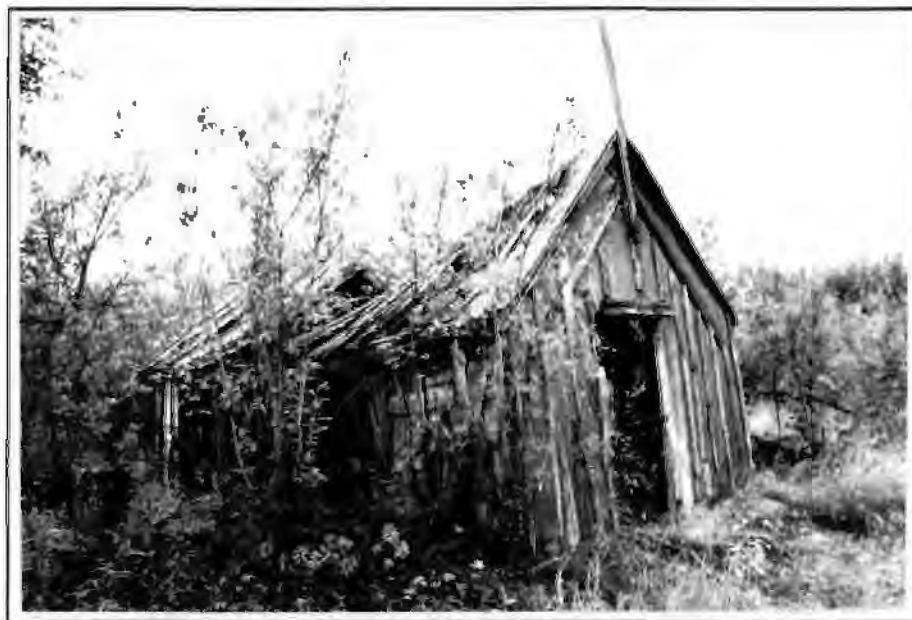
Figure 158. The Miscovich Blacksmith Shop,  
1993. The view is looking southwest.

The Miscovich Blacksmith Shop (IDT-227) is a rectangular, one-story, wood frame building (Figure 158). The foundation is on grade. The partially collapsed gable roof is covered with roofing felt over wood decking. The exterior is covered with roofing felt over horizontal wood siding. The main entry is on the north elevation and contains a door opening but the door is missing. The building is in poor condition.

Peter Miscovich built the blacksmith shop in the 1920s in Flat. It was located near the site where Alex Matheson later built his home (IDT-102). The building served as his blacksmith shop when he was leasing the Guggenheim mining claims in the early 1920s. Peter Miscovich moved the building in 1924 when he started building the Discovery Camp. In recent decades, the Miscovich family has used the building for storage (Miscovich 1995:VI-100-101; Barnett 1995:162).

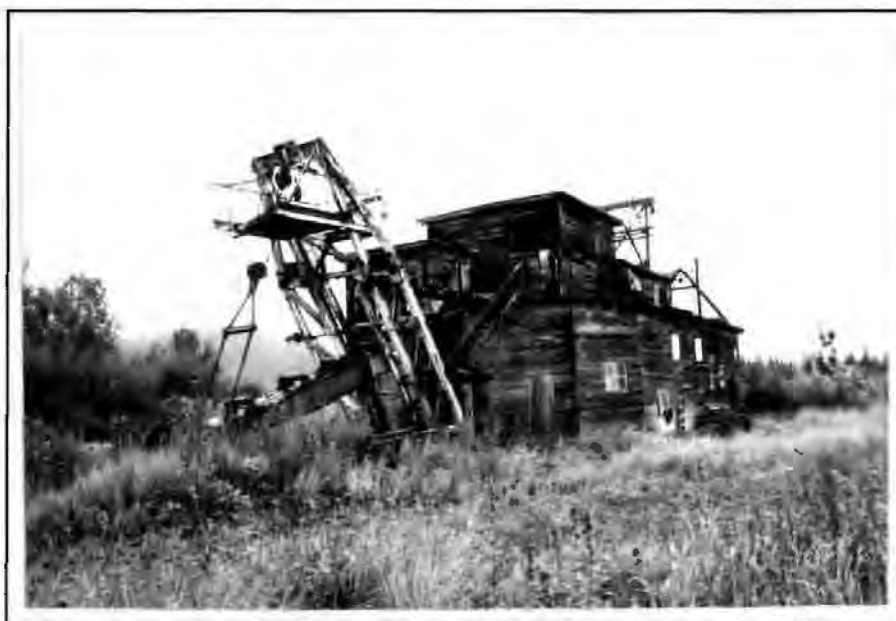
**Figure 159. The Riley/Miscovich Dredge, 1993. The view is looking northeast.**

The Riley/Miscovich Dredge (IDT-220) is a three-story, steel frame structure (Figure 159) located three-quarters of a mile east of the Discovery/Peter Miscovich Camp. The hull is made of steel pontoons and rests on a shelf in a dredge pond. The flat roof is covered with roofing felt. The dredge measures 40'x220' and the exterior is covered with horizontal wood siding. Harry Donnelley converted the dredge from a wooden hull to a steel hull in 1938. The gasoline engine was also converted to a three-cylinder, 125 horsepower Enterprise marine diesel engine. John Miscovich replaced the wood-burning boiler, which was used to keep water used in the dredge from freezing in the spring and winter, with an oil-burning boiler in 1959. The dredge had 56-3.5 cubic foot buckets. The bucket line is about 40' south of the dredge.

The Union Iron Works of San Francisco built the Riley Dredge. The dredge was shipped to Nome, but not used there. In 1914, the Riley and Marston Mining Company installed the dredge on the right limit of the Discovery Claim on Otter Creek, two miles east of Flat (Brooks 1914:56). The Riley Investment Company acquired ownership of the dredge and it mined near the confluence of Black and Otter Creeks from 1914 to 1920. It moved upstream toward Granite Creek, mining claims

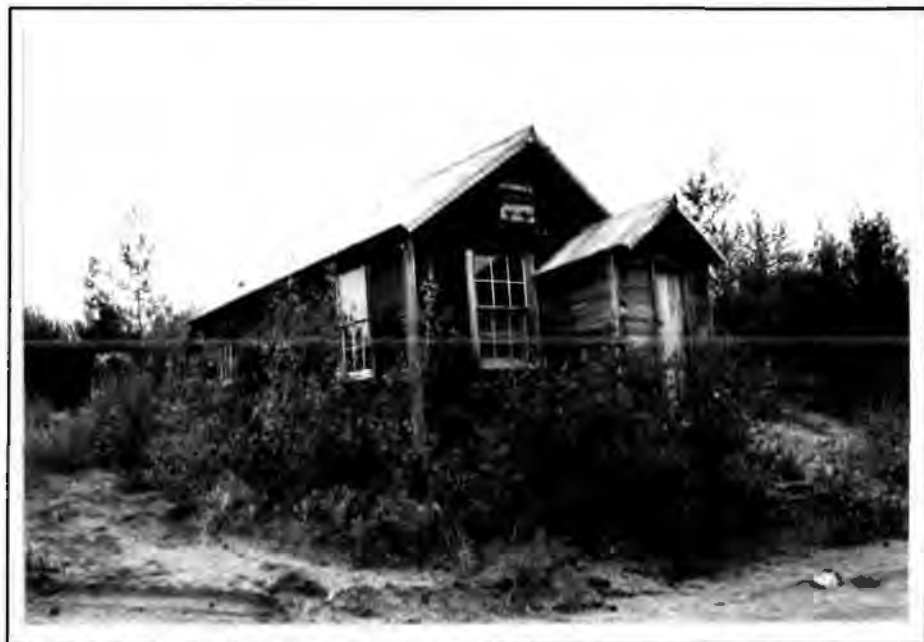
**Figure 161. The Golden Horn Assay Office, 1993. The view is looking southwest.**

The **Golden Horn Assay Office (IDT-233)** is a rectangular, one-story, wood frame building (Figure 161). The foundation is timbers on grade. The gable roof is covered with corrugated metal. Shiplap siding covered by roofing felt covers the exterior walls of the building. An arctic entry with shiplap siding and a plank door is on the eastern half of the north elevation. Corrugated metal covers the gable roof. A 6/6 double-hung window is located west of the arctic entry. A 6/6 double-hung window and a six-light, fixed sash window are located on the east elevation of the building. A six-light, fixed sash window, a 6/6 double-hung window, and a five-panel door are on the west elevation. A shed roof addition on the south elevation has shiplap siding. The roof is covered with corrugated metal. A single-light, fixed sash window faces south.

The assay office was built in the 1930s. Bert Needing, the mine manager, lived in the building during the 1930s. Living quarters were located in the front (north end) of the building. Assay activities were conducted in the back of the building (Miscovich 1995:VI-98-99).

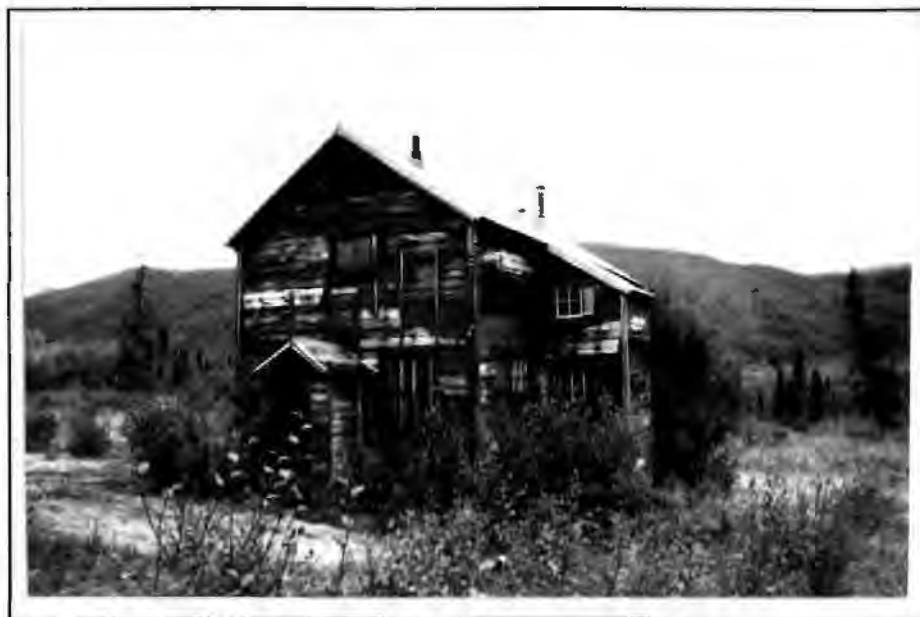
**Figure 162. The Golden Horn Bunkhouse, 1993. The view is looking northwest.**

The **Golden Horn Bunkhouse (IDT-232)** is a rectangular, two-story, wood frame building (Figure 162). The foundation is timbers on grade. Corrugated metal covers the gable roof. The siding is shiplap covered by roofing felt. The main entry is on the south elevation. A gable roof arctic entry is centered on the ground floor. It is flanked by two 6/6 double-hung windows. A six-light, fixed sash window is located above the arctic entry on the second floor. Three 6/6 double-hung windows are located on the ground floor of the west elevation. The

second floor has three six-light, fixed sash windows. Two five-panel doors are located on the ground floor of the north elevation. The second floor has a six-light, fixed sash window on top of a boarded up window opening. A two-story shed roof addition is centered on the east elevation and is flanked by two six-light, fixed sash windows on the ground floor. A six-light, fixed sash window is located on the second floor. A

A six-light, fixed sash window is centered on the first and second stories of the south elevation on the east addition. A six-light, fixed sash window is centered on the south elevation of the second story of the addition.

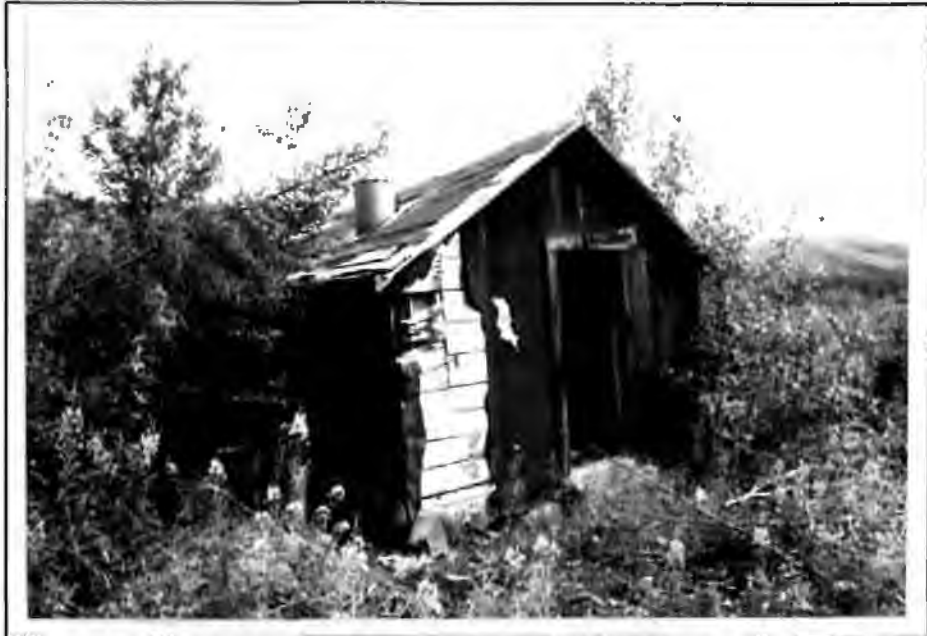
**Figure 165. Small Bunkhouse, 1993.**  
The view is looking southeast.

The **Small Bunkhouse (IDT-237)** is a rectangular, one-story, wood frame building (Figure 165). The gable roof and exterior are covered with roofing felt over horizontal siding. The building measures 17'9"x20'4" and the roof line is oriented east-west. The main entry is on the east elevation but has no door. A window opening is located on the north and west elevation. The cabin is in poor condition.

The bunkhouse served as living quarters.

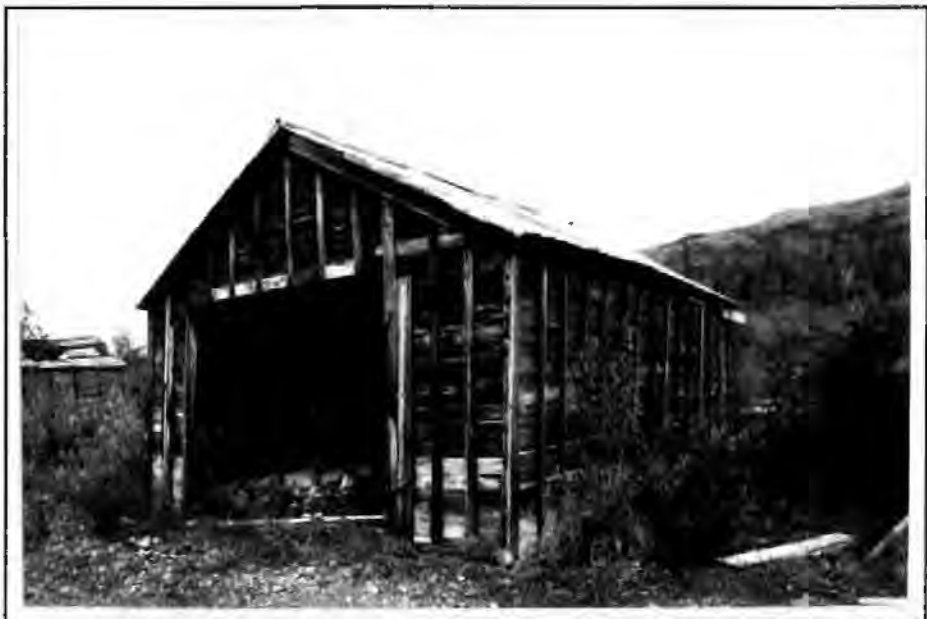
**Figure 166. The Garage at the Fullerton Camp, 1993.**  
The view is looking northeast.

The **Garage (IDT-238)** is a rectangular, one-story, wood frame building (Figure 166). The foundation is on grade. The gable roof is covered with corrugated metal. The exterior is covered with roofing felt and battens over shiplap. Most of the roofing felt is missing from the walls. The building measures 17'4"x20'7" and the gable roof is oriented east-west. The garage has large door openings on the east and west elevations, but the double

doors are missing. Most of the interior of the garage is flooded by water from a beaver pond located immediately to the east.

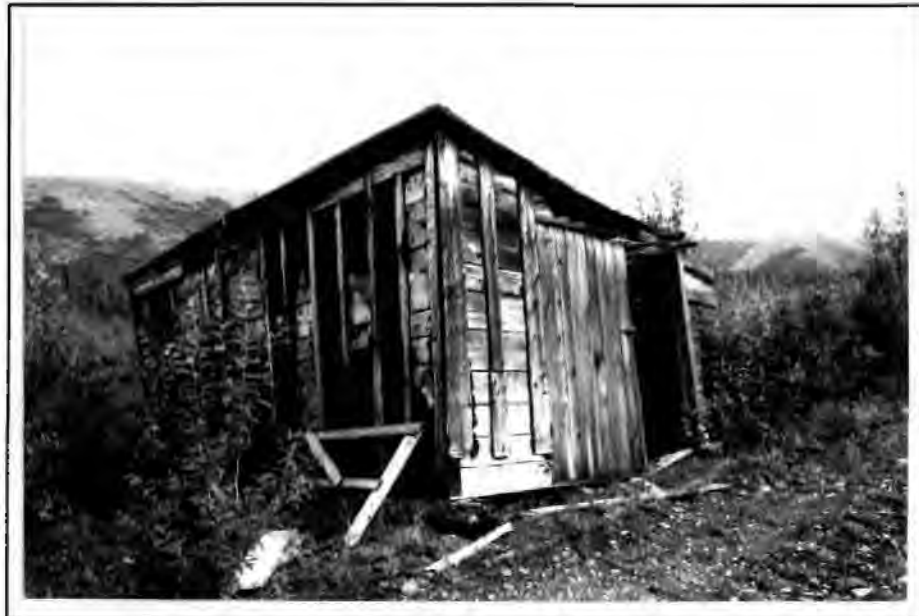
**Figure 167. The Fullerton Storage Shed, 1993. The view is looking southeast.**

The **Storage Shed (IDT-239)** is a rectangular, one-story, wood frame building (Figure 167). The foundation is logs on grade. The partially collapsed shed roof is covered with roofing felt over wood decking. The exterior walls are covered with roofing felt and batten boards over horizontal siding. Most of the roofing felt is missing. The building measures 11'6"x 20'7". The main entry is on the west elevation, which has a large plank door and a smaller door opening.

The door to the latter is missing. The building is in poor condition and is partially flooded by a beaver pond immediately to the east.

The Fullerton brothers used this building to store supplies and equipment during their mining operations on lower Flat Creek in the late 1950s.

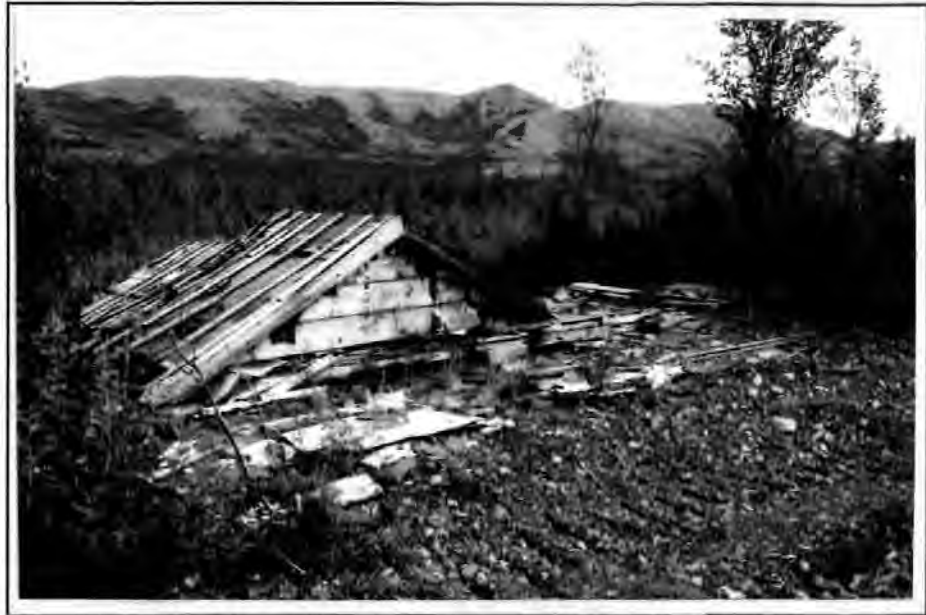
**Figure 168. The ruins of the Fullerton Work Shop, 1993. The view is looking southeast.**

The **Work Shop Ruins (IDT-241)** consists of the remains of a rectangular, one-story, wood frame building (Figure 168). The foundation is wooden blocks. The floor is made of decking and is intact. The rest of the building has collapsed. Roofing felt and batten boards cover the gable roof, which is intact. The building measures 17'2"x18'4". The exterior was

covered with roofing felt over wood siding. The north wall is partially intact, but is laying north of the building foundation. Sections of the other walls and artifacts, such as rusted tools and five 50 gallon barrels, are scattered around the ruins.

The Fullertons used this building as a workshop to repair equipment while mining on lower Flat Creek.

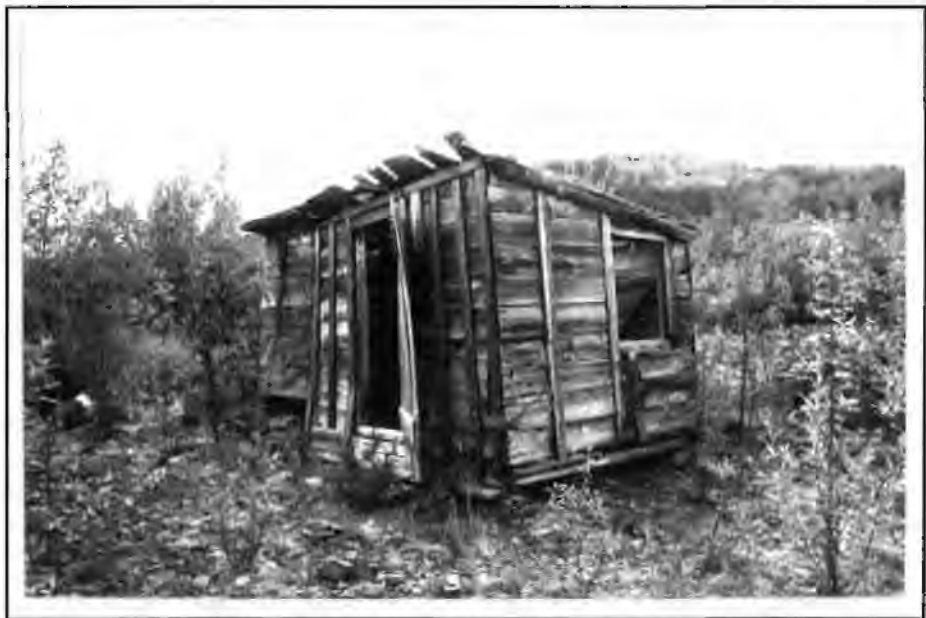
The **Fullerton Shed (IDT-242)** is a rectangular, one-story, wood frame building (Figure 169). The foundation is horizontal timbers. The partially collapsed shed roof and the exterior walls are covered with roofing felt over wood siding. The building measures 7'x13'4". The main entry is on the east elevation and contains a plank door. A six-light, fixed sash window is located on the north elevation. Artifacts inside the building include a hand-cranked portable phonograph, fuel cans, clothing, a lantern, a boot, black plastic sheeting, and structural debris from the collapsed portion of the roof. A small automobile radiator is located just south of the shed.

The Fullerton brothers used this shed for living quarters.
